# Manhole Inspection Summary

Manhole # S41WW\_011MH

**Location** Address: **3220 LOCH RAVEN BLVD**

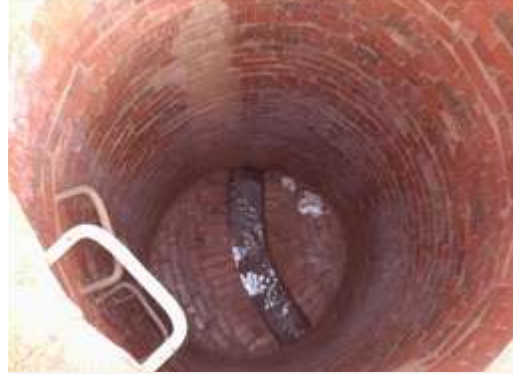
Top View

Bench debris.

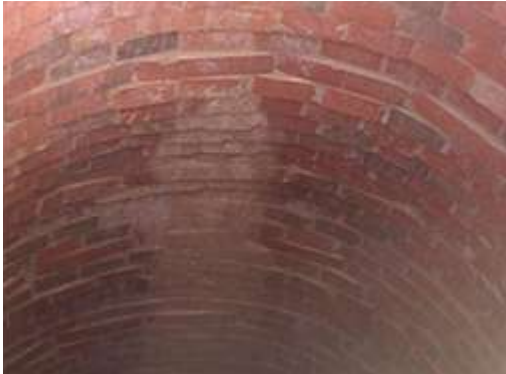
Defect

Infiltration: ☐ None ☐ Joint ☐ Cracks ☒ **Mortar** ☐ Roots ☒ **Wall**

Barrel infiltration.

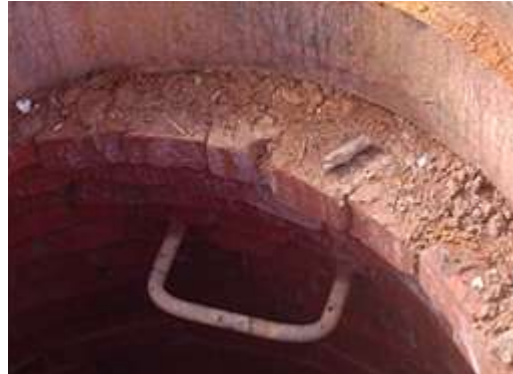
Defect

Condition: ☐ Sound ☐ Cracked ☐ Root Intrusion ☐ Loose Brick ☒ **Deteriorated**

Infiltration: ☐ None ☒ **Joint** ☐ Cracks ☒ **Mortar** ☐ Roots ☐ Wall

Frame leaks. Frame offset. Corbel deterioration and infiltration.

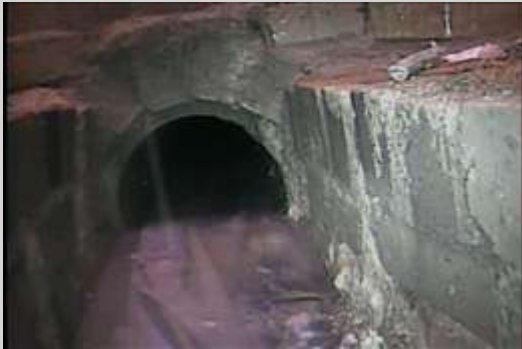
### 10 in. Circular Gravity Sewer Pipe Out @ 12 O'Clock

Deposits: ☐ None ☐ Mud ☐ Sludge ☒ **Debris** ☐ Grease

Silt Depth: **0** (in.) Deposits Extent: **Light**

Infiltration: **Evidence** Pipe Seal Cond: **Unknown**
